Hill Chorlton Residents group

Response to “Chapel and Hill Chorlton parish: speeding on the A51 report”,

27 November 2020

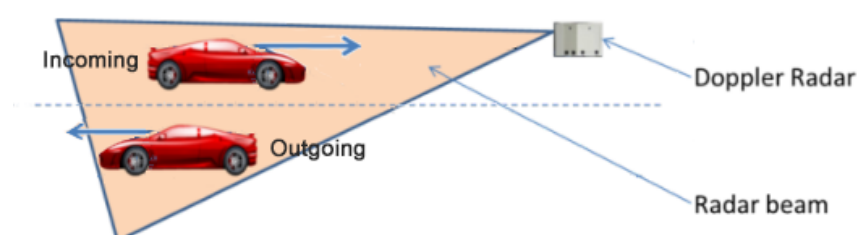
The display illuminates only for "incoming" (westbound) traffic, but vehicles travelling in both directions are recorded. (See diagram)

Diagram showing the radar beam emitted from the front of a SID and covering the full width of the road.

¹ The apparent slowing down of vehicles as they approach and pass the SID (as observed by the changing numbers on the display) is due to the so-called “cosine effect”, where the angle that the vehicle subtends to the radar device changes as it passes. This is easily observed by asking a driver to travel past the device at a constant speed and watching the numbers on the display. The most accurate reading is when the vehicle is furthest away from the device.
